Inter-Story Drift Testing of KNAPP RICON S VS Connectors

Inter-Story Drift Testing of KNAPP RICON S VS Under Design Load

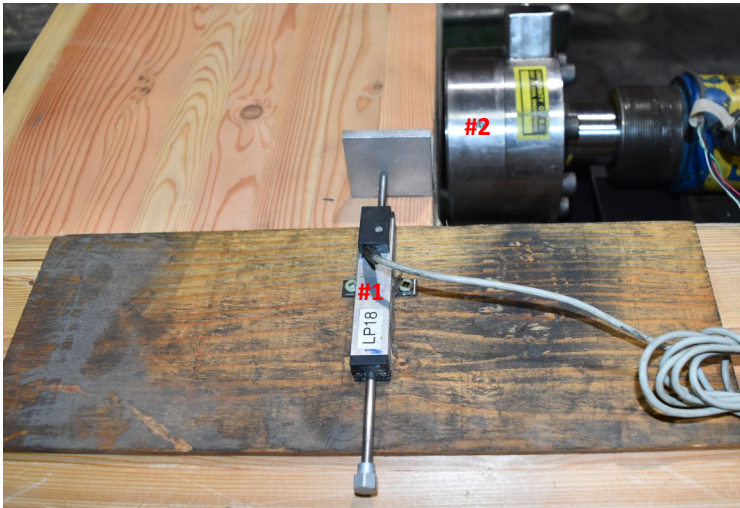
Figure 3: Displacement recording (#1) at interface of beam and column and constant design shear load application actuator (#2)

⇒ *The term "Gap" refers to the LDVT recording at the connection (see Figure 3)

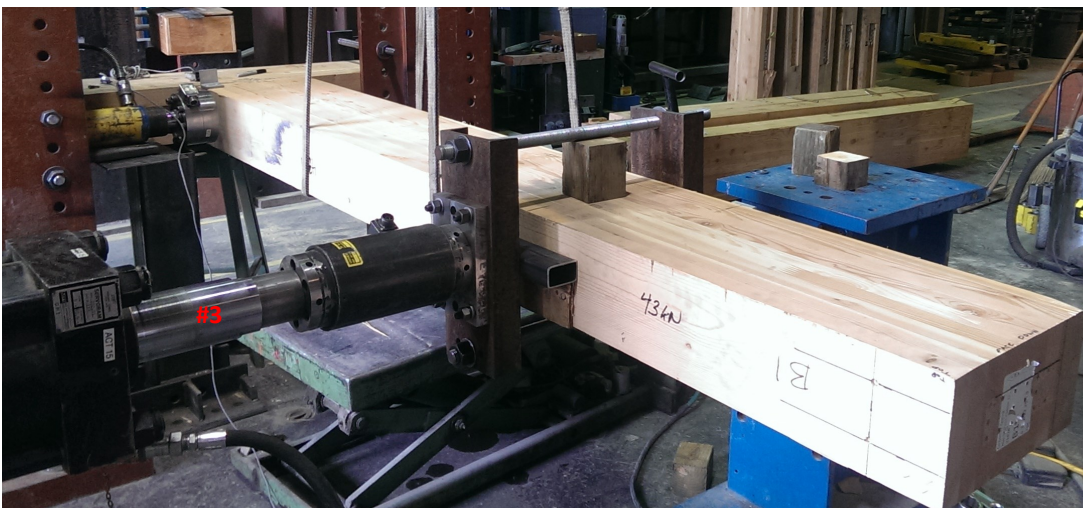
Figure 5: Displacement application actuator (#3) at 65 1/4" away from interface of beam and post

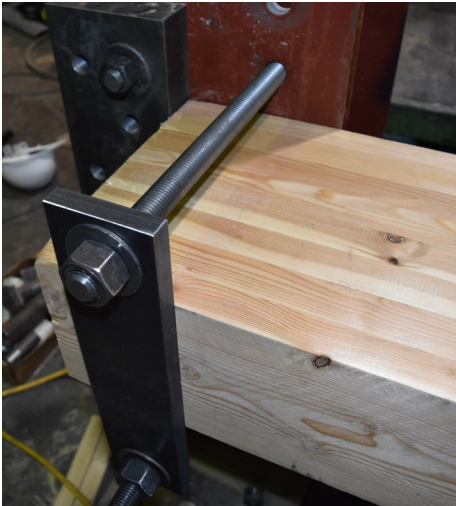
Figure 6: Threaded rod tie to reaction frame at post member

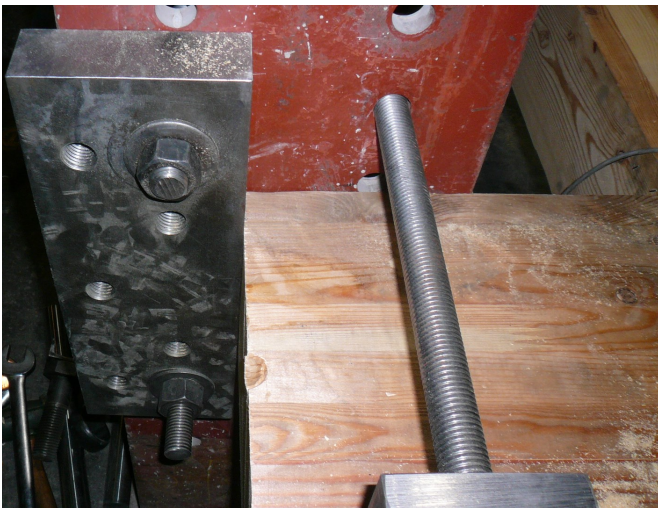
Figure 7: Lateral bearing point at post to reaction frame

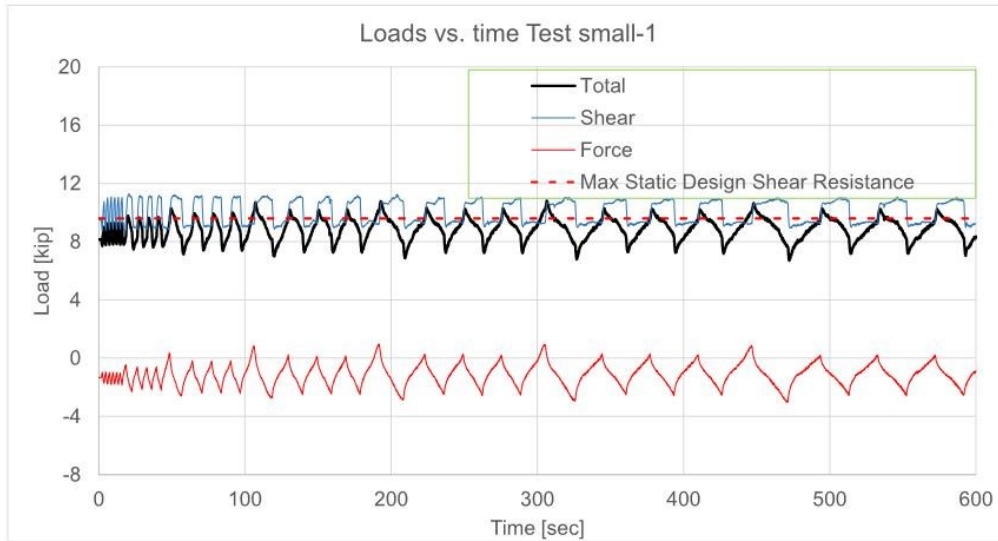
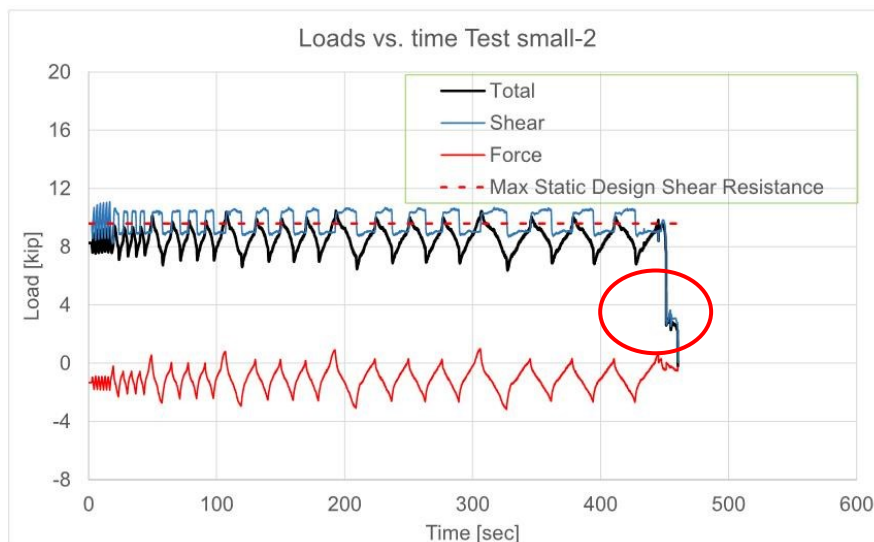
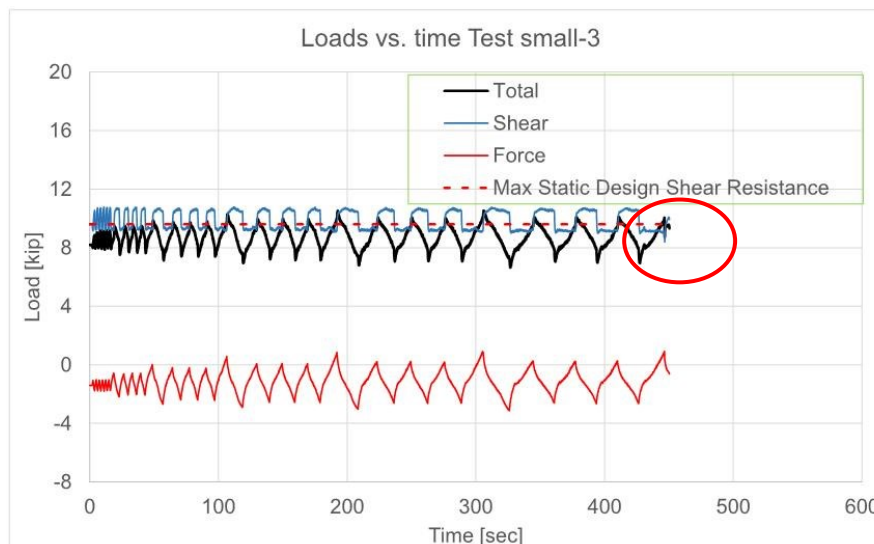
Note: RICON S VS 200x60 collar bolt fracture observed in test and respective machine recordings

Note: RICON S VS 200x60 collar bolt fracture observed in test and respective machine recordings.

Three post to beam specimen of RICON S VS 200x60 and RICON S VS 200x80 under the specified design load has indicated that RICON connectors can resist static forces while subjected to a reversed cyclic rotational force. During testing two out of three RICON 200x60 connectors observed ultimate failure at the collar bolt through a combined tension and shear fracture of the bolt. Ultimate failure occurred after the 2.5° rotation and full actuator displacement in reversed cyclic fashion was applied. The actuator pushed the beam member 3" one directional and failure occurred before 3" of displacement was reached in the opposing cycle. A picture of the collar bolt failure is shown in Figure 15. Failure on the load bearing full thread ASSY VG CSK screws was not visually observed. An inter-story drift value of approximately 4% was calculated with the recorded string pot measurement divided by the distance of the string pot to the center of rotation (see Figure 2 for detailed measurements). The applied reinforcing screws perpendicular to the grain of the beam member avoided tension perpendicular to grain failure effectively and no failure was observed in the glulam members. The loading protocol was stopped after ultimate failure occurred or the maximum actuator stroke was reached (as reflected in the plots shown in this report).

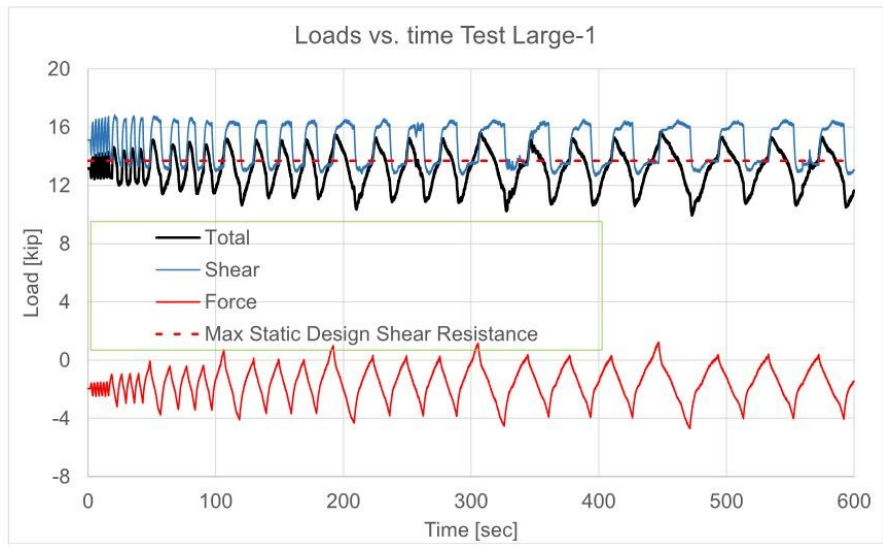
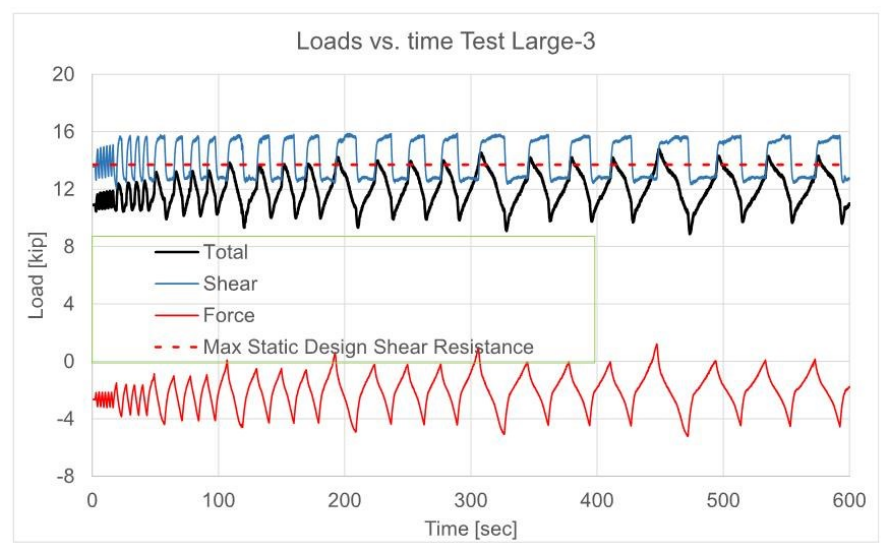
Note: RICON S VS 200x80 connectors without apparent connector failure

During testing of the RICON S VS 200x80 connectors no ultimate failure was observed at the connectors, the ASSY VG CSK screws or the timber members. Intended damage on the connectors such as plastic yielding of the collar bolt, plastic deformation of the V-notch and early indication of perpendicular to grain splitting failure in the beam member was however noticed. The loading protocol was completed as desired after approximately 10 minutes of loading while the full actuator stroke was reached.

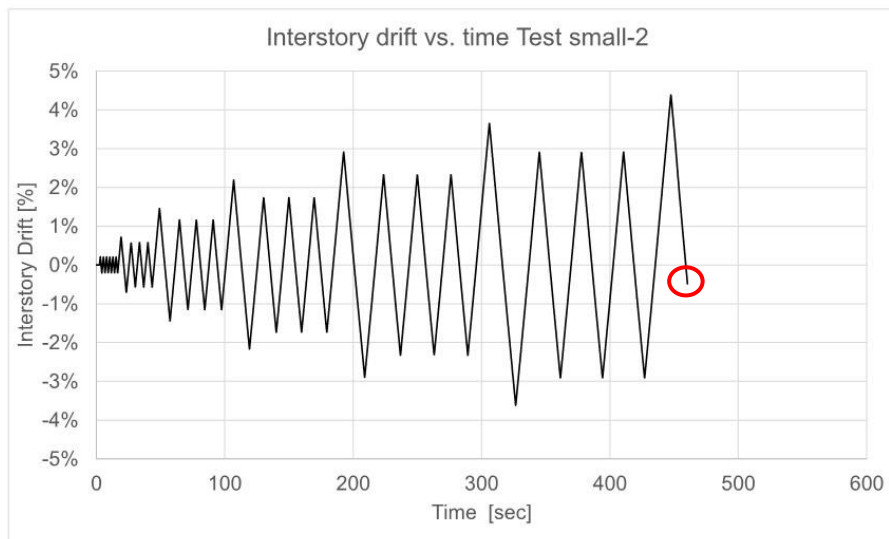
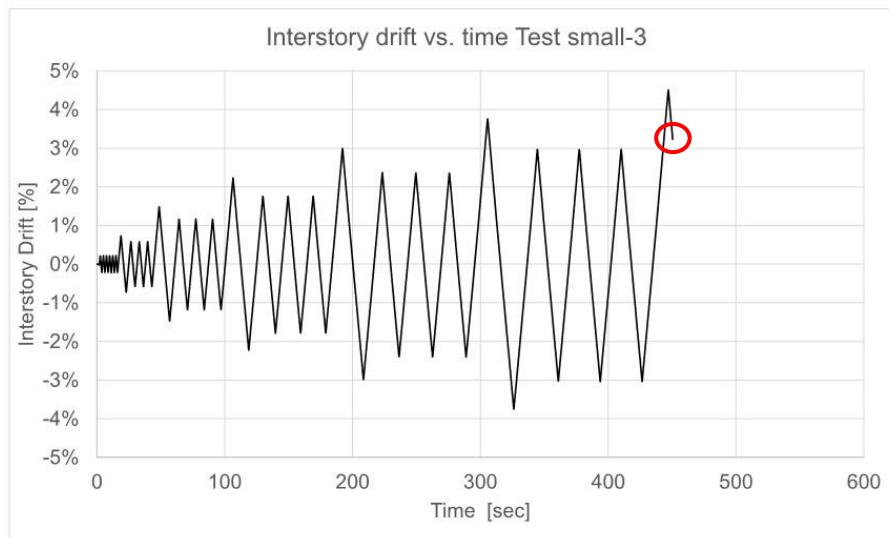
Note: RICON S VS 200x60 collar bolt fracture observed in test and respective machine recordings with failure indication

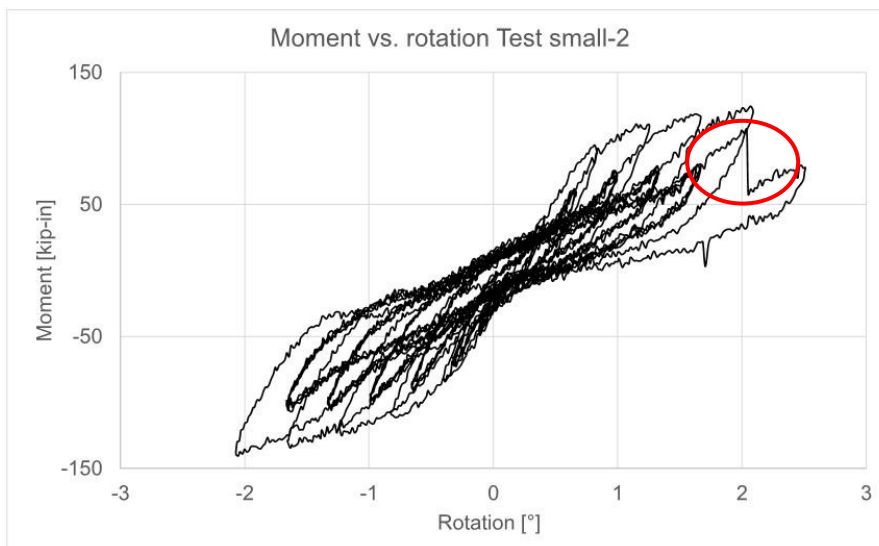
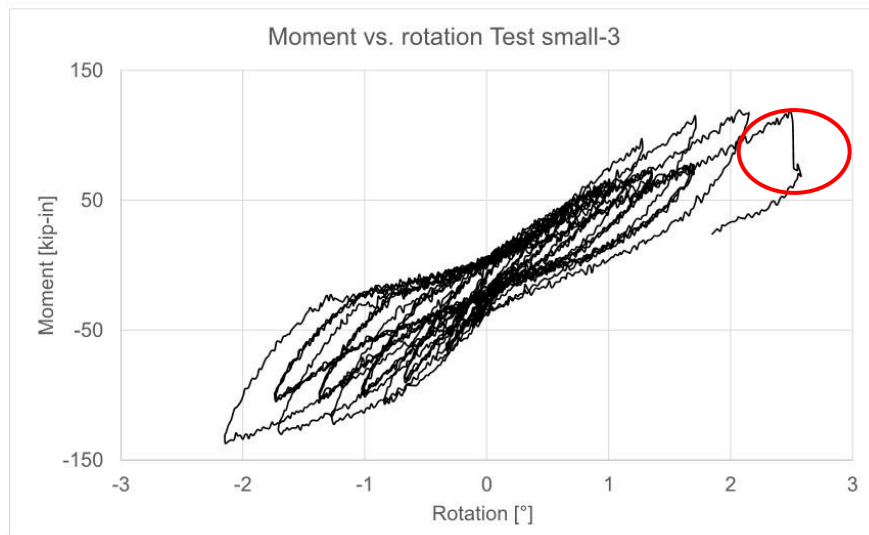
Note: RICON S VS 200x60 collar bolt fracture observed in test and respective machine recordings with failure indication

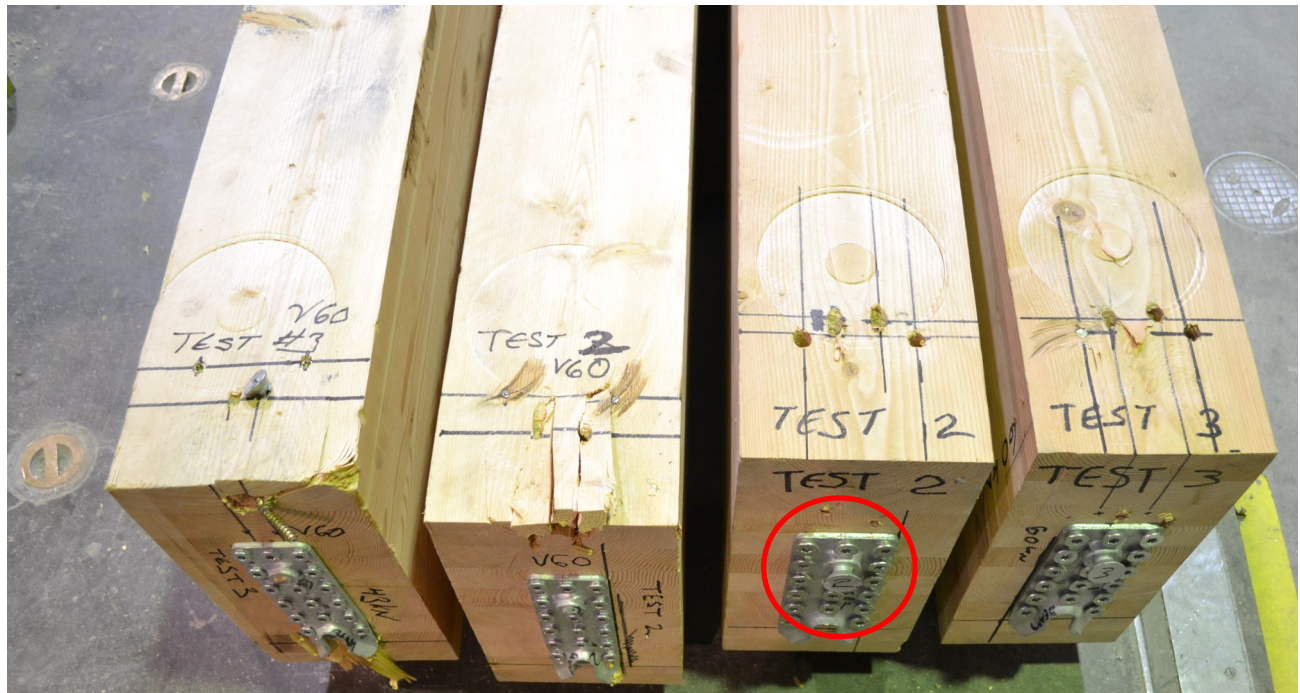
Figure 9: Example of collar bolt failure at maximum drift and load in beam member Ricon S VS 200x60 in 2 out of three tests. Figure 10: Example of collar bolt yielding at maximum drift and load in beam member RICON S VS 200x80 in 3 out of three tests

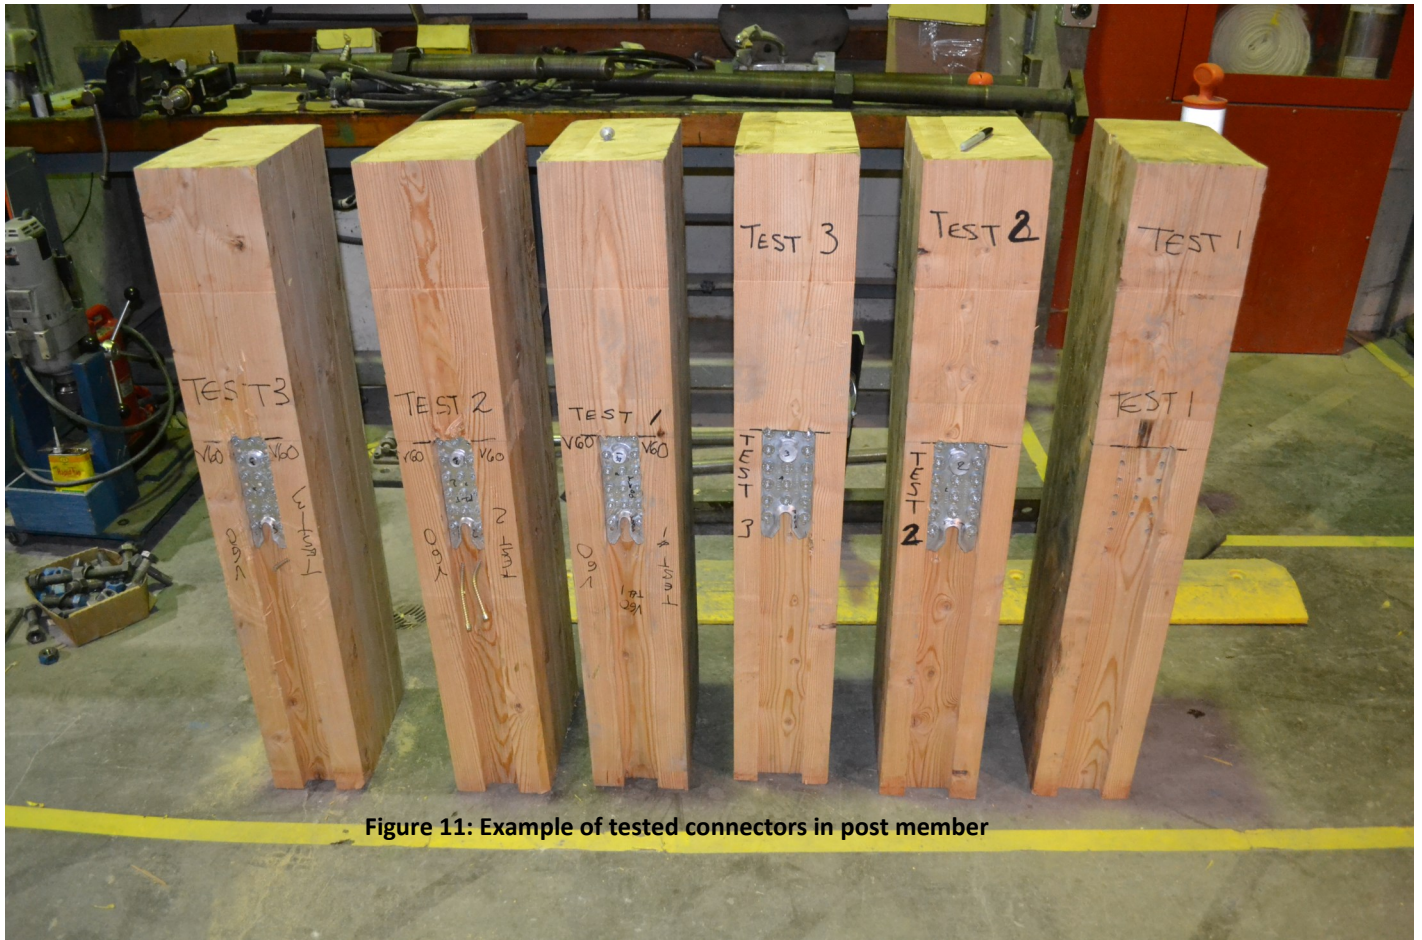
Figure 11: Example of tested connectors in post member

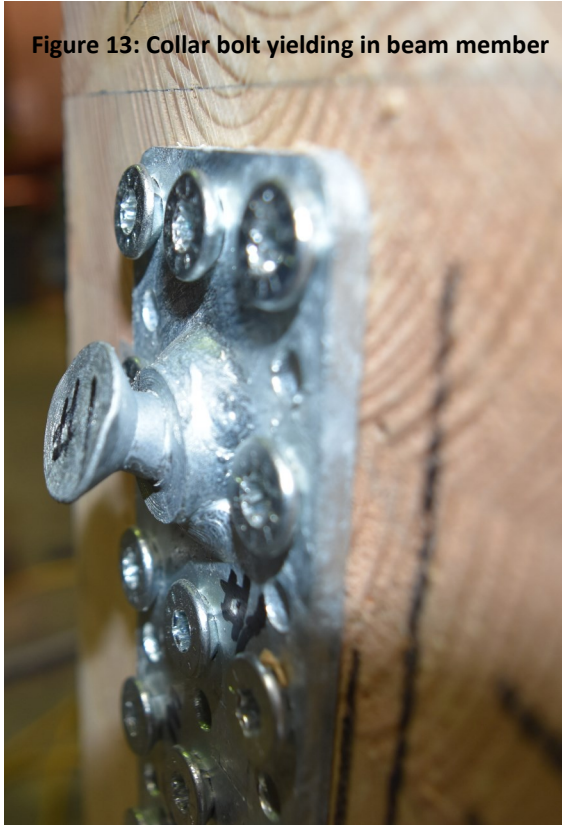
Figure 13: Collar bolt yielding in beam member

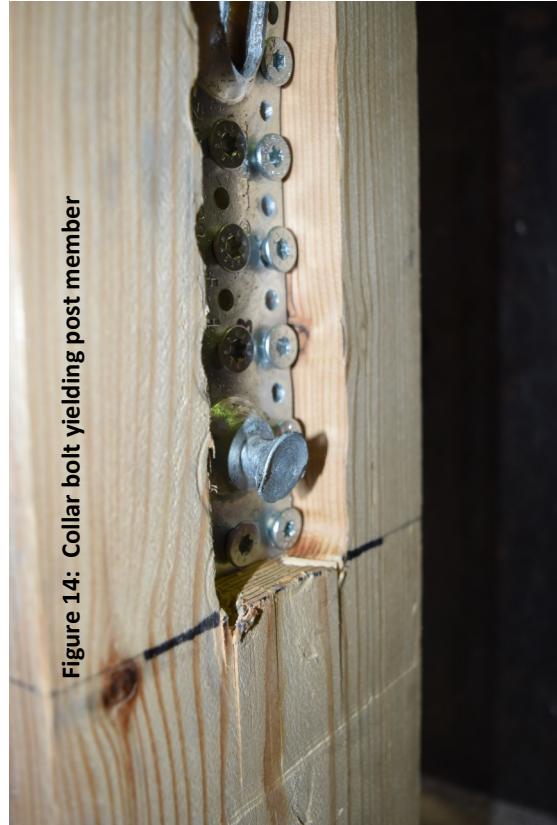
Figure 14: Collar bolt yielding post member

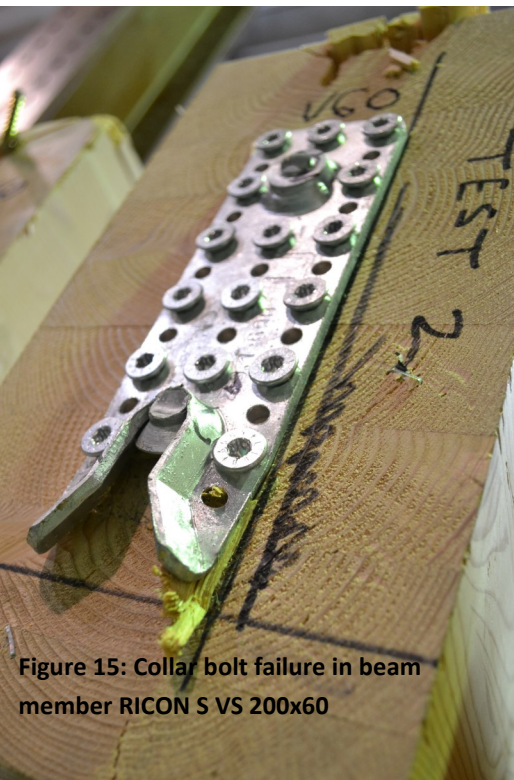
Figure 15: Collar bolt failure in beam member RICON S VS 200x60

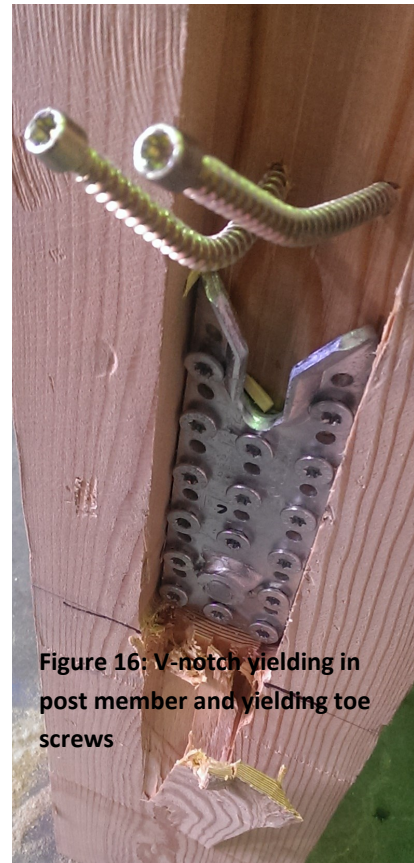
Figure 16: V-notch yielding in post member and yielding toe screws

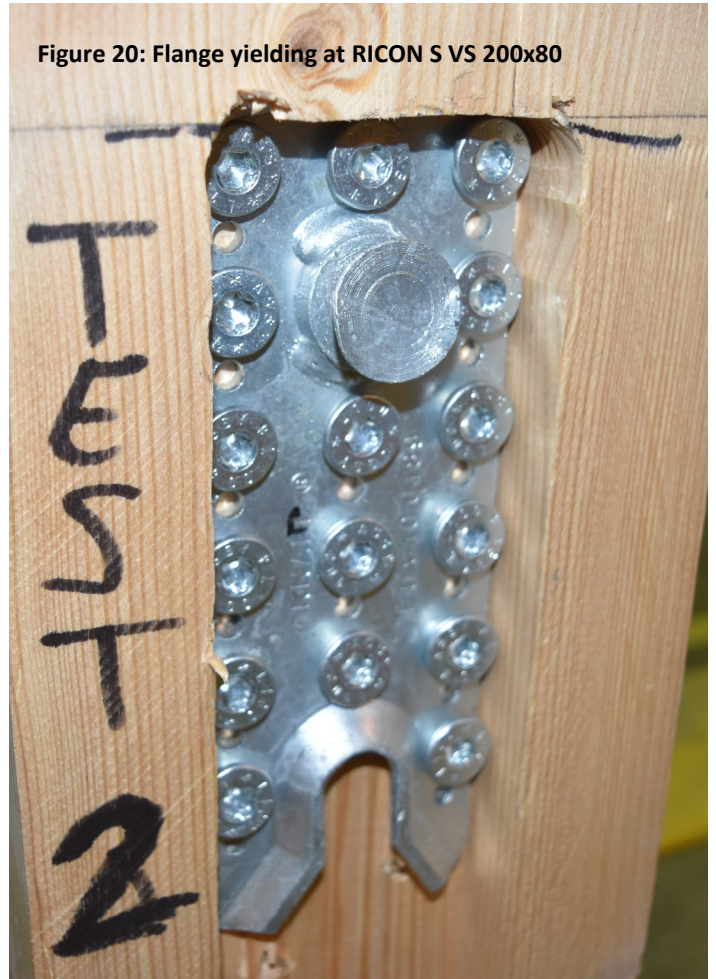
Figure 20: Flange yielding at RICON S VS 200x80

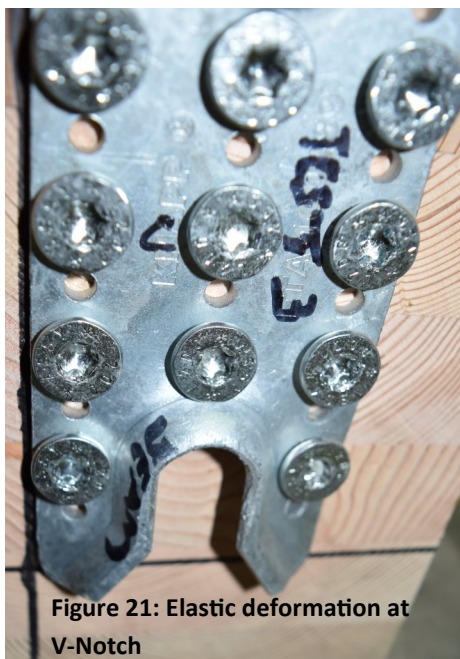
Figure 21: Elastic deformation at V-Notch
